Significance of Defects Inside In-Service Aged Winding Insulations

Christof Sumereder and Tilman Weiers

Abstract—This study aims to gain insight into the consequences of local defects in stator winding insulation; therefore, optical (microscopic) inspections and voltage-endurance tests have been carried out on in-service aged generator bars. In this context, generator bars with mica-bitumen insulations and generator bars with mica-epoxy insulations were investigated. The mica-bitumen insulations had been in service for 43 years in a 12 kV hydro-generator. The generator bars with mica-epoxy insulation had been dismantled from two identically constructed 10.5-kV generators after 35 and 36 years of service. The time to breakdown values obtained from the voltage-endurance tests were evaluated using a Weibull distribution. Apart from the scale parameter, Weibull exponent of this distribution allowed for the identification of early failures. The voltage-endurance tests carried out on replacement bars for these generators did not yield any early failures; such failures, however, were detected on both types of the in-service aged insulations. In particular, these occurred at high levels

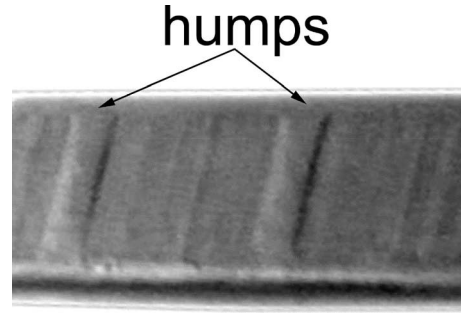
Along the slot sections, the insulations exhibited humps at cooling slots (Fig. 2) of the stator. As there were sites at which insulation had expanded into these cooling slots, the degradation of the insulation was expected to vary locally.

Fig. 2. Humps on the surface of mica-bitumen insulations at cooling slots of the stator.

The microscopic analysis of the groundwall insulation showed that the mica tapes had separated from each other during several decades of service. This delamination was very well visible outside the slot sections of the bars and below the humps shown in Fig. 2. This finding further contributed to the expectation for the residual voltage endurance to vary locally.

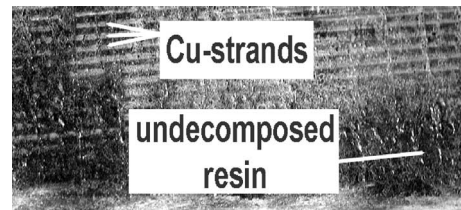
Fig. 4. Undecomposed resin on the surface of copper strands, which are delaminated from the mica-epoxy groundwall insulation.

Delaminations between copper strands and the groundwall insulation were also found in the generator bars with resin-rich mica-epoxy insulation systems. These delaminations were associated with resin decomposition zones that were caused by the partial discharge activity in these delaminations (Figs. 4 and 5). The appearance of the decomposed resin can be described as white or gray powder. In particular, the resin was, often, found to be totally decomposed at the edges.

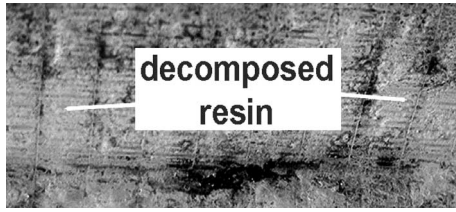
Fig. 5. Decomposed epoxy resin on the surface of copper strands.

exponent < 1) occurred only on the in-service aged bars, while none of the tested replacement bars failed early. The dissection of these bars with early failures revealed resin decomposition zones, as described earlier (Fig. 5). Bars that were tested at an elevated electric stress ($\hat{=} 3 V_{pp}$) were, especially, likely to show early failures. So, the choice of the test level in voltage-endurance tests on in-service aged insulations is crucial for estimating the reliability of insulation.

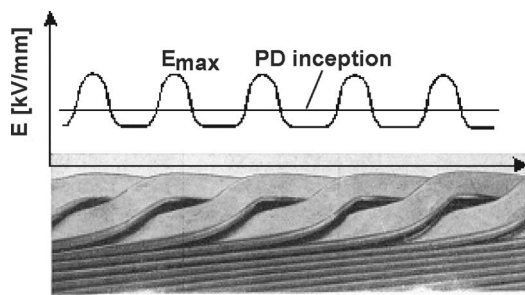
Fig. 7. Elevated electric field that leads to PD inception at Roebel transpositions.

Under the microscope, black colored spots could be observed all over the insulation. These spots (indicated in Fig. 6) are caused by the partial discharge activity at high electric field sites. Due to Roebel transposition of copper strands (Fig. 7), such high electric field sites occur at the edges of copper wires. The black colored spots closely followed the pattern of Roebel transposition.

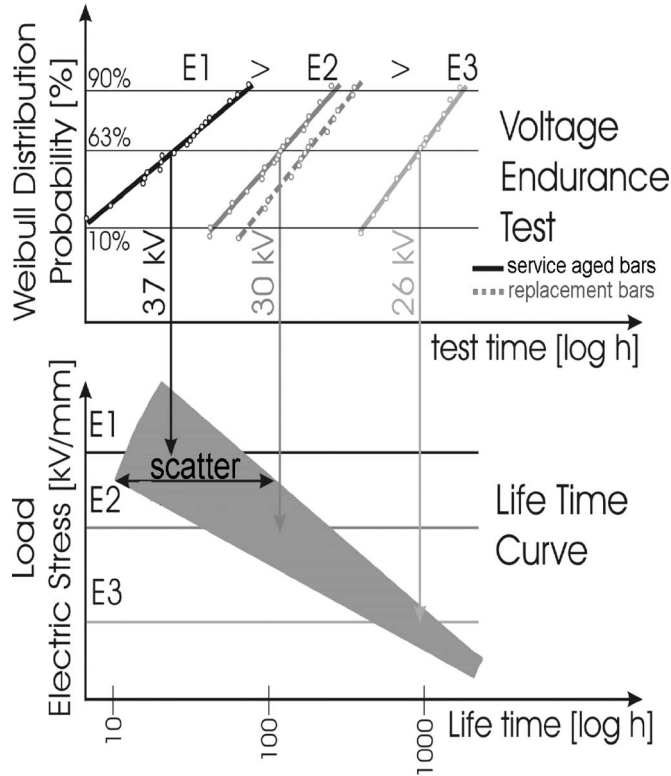
Fig. 10. (Scatter) of the time to breakdown values obtained from in-service aged mica-epoxy insulations depending on the electric stress (E1, E2, and E3).

Due to the availability of 63 generator bars and several replacement bars with mica-epoxy insulation systems, the voltage-endurance tests on these insulations could be carried out at three voltage levels: early breakdowns occurred particularly at the higher test levels (37 and 30 kV). Some of these happened very early, so that other factors, apart from electrical aging, must be crucial. The characteristic breakdown behavior of the replacement bars was unambiguous. No early failures occurred. Compared to the in-service aged specimens, the characteristic lifetime (scale parameter η) of the replacement bars was longer by a factor of 2.5. The test durations of all generator bars were statistically evaluated using two-parameter Weibull distributions (1). Fig. 10 shows the results of the statistical evaluation. For each of the three test levels, the corresponding Weibull curve is plotted. In addition, Fig. 10 includes a dashed line that is the

The slope of the Weibull curve corresponding to the higher test levels is smaller than the slope obtained from tests at 26 kV. At the lowest voltage level and during the tests on replacement bars, no early failures were detected. This results in a larger slope of the Weibull curve (Fig. 10). Weibull exponent β obtained from the statistical evaluation of time to breakdown values (1) confirms the assumption of early failures. Weibull exponents corresponding to the 37- and 30-kV test levels were less than 1. This means that these two probability functions were dominated by failures after short test duration. Weibull exponent corresponding to the lowest test voltage of 26 kV and to the tests on the replacement bars were very similar and greater than 1. This behavior is interpreted as pure (electrical) aging of the resin-rich insulation system.

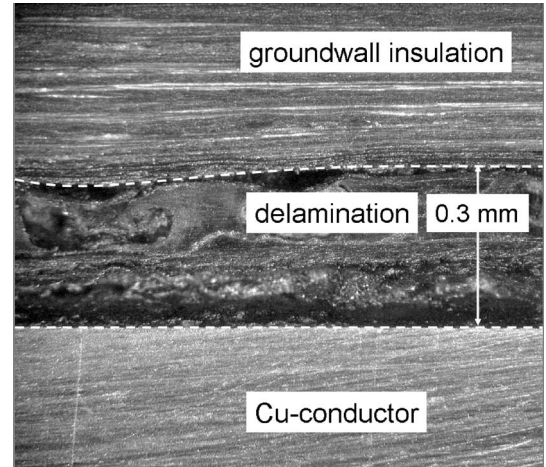
Fig. 11. Delamination found at an early failure site.

On the other side, time to breakdown values that were less than 1 min were found; these occurred when the electrodes were embedded within the humps (Fig. 2) or above a (large) delamination between copper strands and the groundwall insulation. Fig. 11 gives an example of a (large) delamination found at an early failure site. The delamination was found between a high-voltage electrode (Fig. 9) embedded outside the slot section of the tested bar and copper conductor. This confirms the assumption that the residual voltage endurance of mica-bitumen insulations is governed by local defects and that it varies locally.
