## IMPROVING THE SAFETY OF AN OLD AUSTRIAN DAM

Updating of the design flood for the 90-year old Gosau dam in the Austrian Salzkammergut region to meet present-day safety standards made it necessary for the owner and operator, Energie AG Oberoesterreich, to raise the dam's discharge capacity from approximately 40m<sup>3</sup>/s to 70m<sup>3</sup>/s by providing an overflow spillway section at the dam crest. Two energy dissipation alternatives were considered, one with a stilling basin and one with a ski-jump. The complexity of the situation led the owner to resort to hydraulic scale-model tests for the design studies. The results proved both alternatives to be technically feasible. In the end, the ski-jump variant was chosen and the design submitted to the authorities. In addition, a bottom outlet connecting to the upstream end of the existing spillway tunnel was provided to enable water-level drawdown in the case of emergency. This was studied in a further model test. The results have shown that both the bottom outlet and the old spillway can be expected to work perfectly well. Following approval by the Water Right Authority, construction was commenced in the autumn of 2003 and co

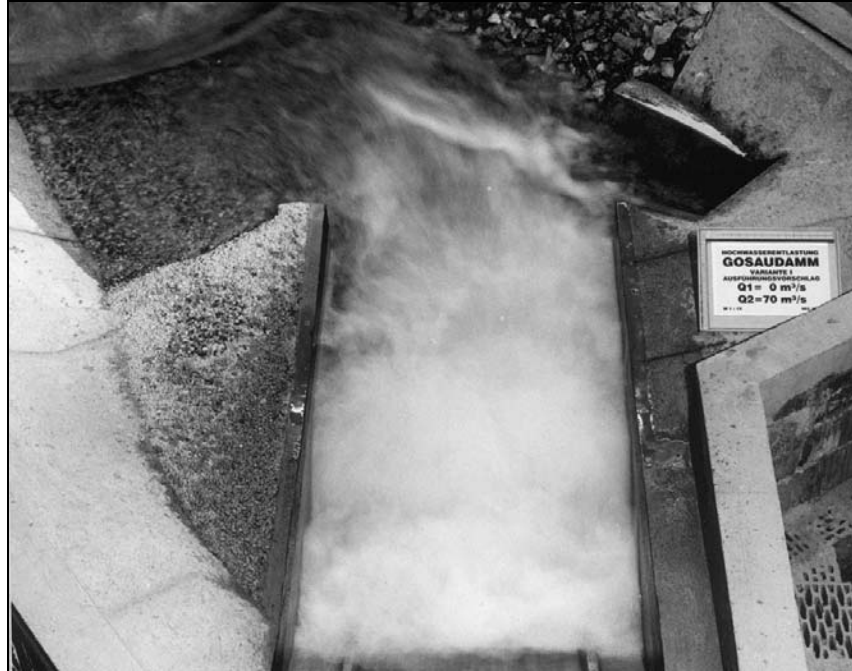
Figure 5. Stilling-basin Alternative ( $Q_1 = 70 \text{ m}^3/\text{s}$ ,  $Q_2 = 0 \text{ m}^3/\text{s}$ )

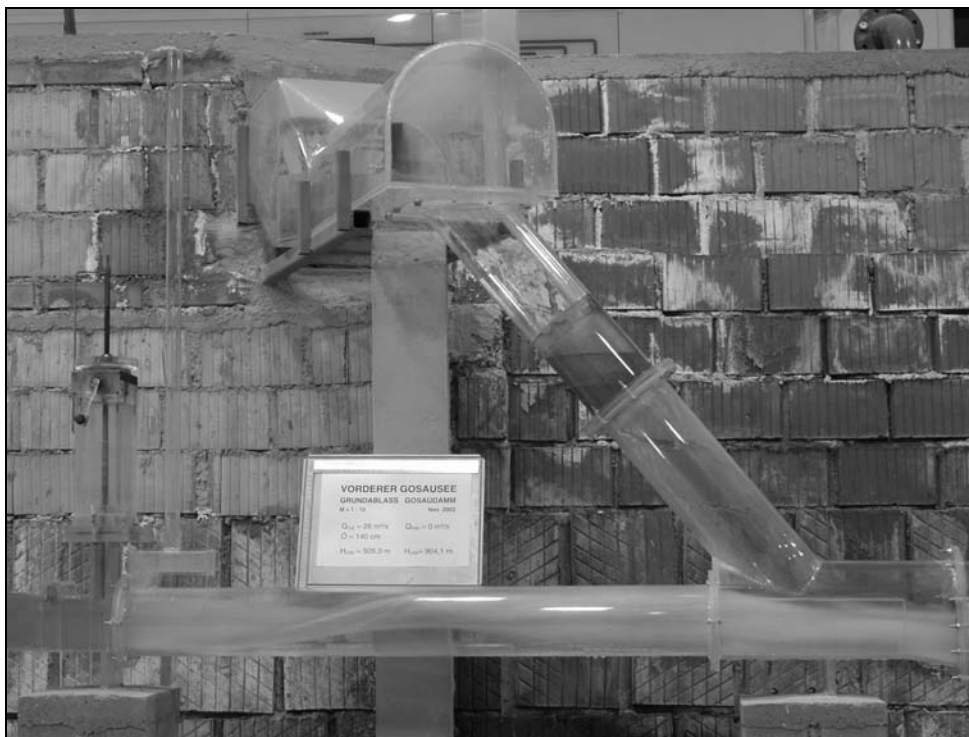
**Bottom-outlet operation** (Fig. 8): The tests have shown that no major problems are expected. The flow downstream of the gates forms a straight rooster-tail jet before reaching the junction. In the discharge tunnel, the flow depth increases from the junction to the tunnel portal (supercritical flow), but with sufficient space remaining between the water surface and the tunnel roof for the flows that were studied.

Figure 8. Model Test of Bottom Outlet Operation ( $Q_{BO} = 30 \text{ m}^3/\text{s}$ )

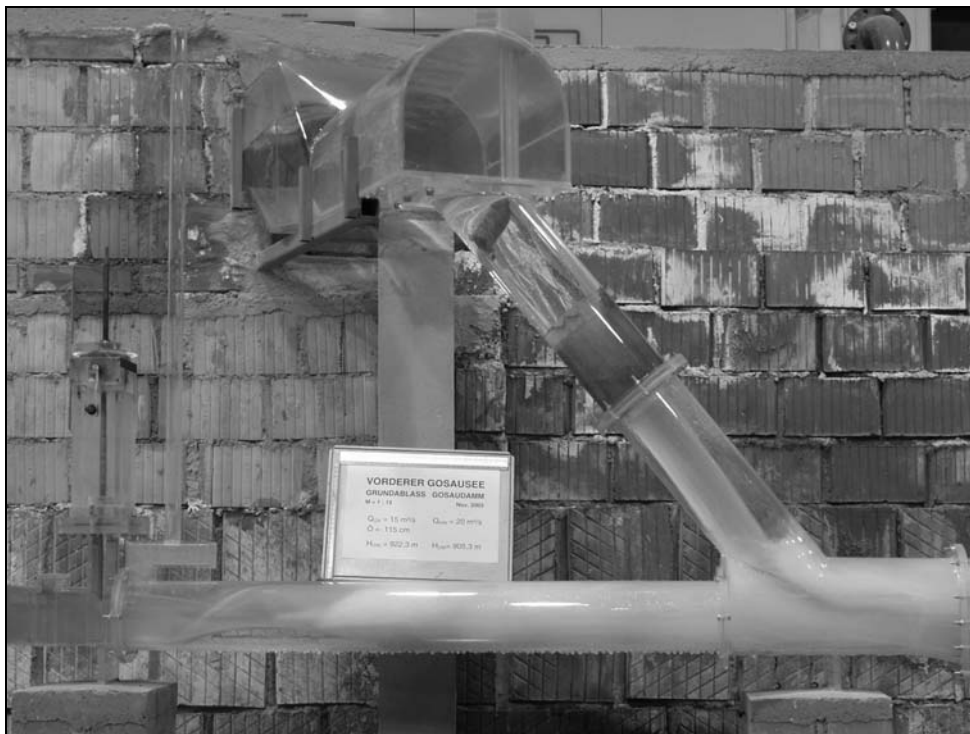
Simultaneous operation of bottom outlet and spillway (Fig. 10): The kinetic energy of the jet emerging below the slide gate displaces the water body towards the junction area. As long as the aeration device is in good working order, no counter pressure can build up behind the gate, so that the flow and, hence, the discharge performance of the tunnel are maintained. In the junction area, the jet shooting down from the throttle is carried along by the horizontal flow from the bottom outlet. This not only reduces the load on the bottom, but causes an increased reflection of the jet to the roof. This effect is the greater, the higher the flow through the bottom outlet.

Flow in the tunnel is without pressure up to a total discharge of 35m<sup>3</sup>/s. As the flow is further increased, free-surface flow changes into flow under pressure and the tunnel cross-section closes up. When the flow velocities are high, water tends to fill the tunnel cross-section quite suddenly, with the risk of causing a water hammer and, hence, damage to the lining. Undesirable effects may be experienced when compressed air bubbles emerge at the tunnel outlets.

Figure 10. Simultaneous Operation of Bottom Outlet and Spillway ( $Q_{BO} = 15 \text{ m}^3/\text{s}$ ,  $Q_{SP} = 20 \text{ m}^3/\text{s}$ )

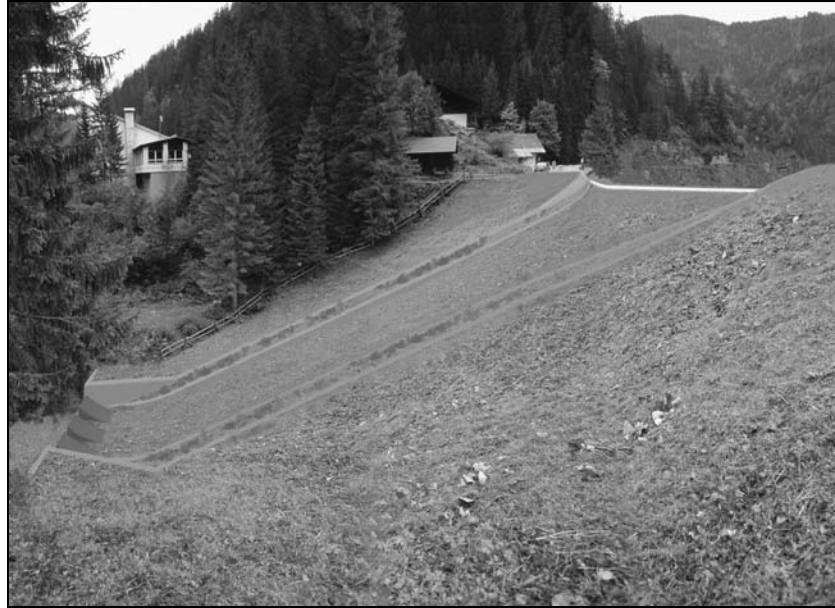
During the final phase of the design studies, the help of the Institute for Ecology in Salzburg was summoned for developing an ecological concept for the project. This has led to a great number of landscape compensation measures. Dam surfaces once paved with stones were planted with grass so as to make them blend with the surrounding landscape. Special techniques were used to grass the chute, bright concrete surfaces were darkened, and the metal-covered ski-jump was painted dark green (Fig. 11). The stilling basin was completely covered with fill and planted with vegetation recovered prior to the construction work.

Figure 11. Overflow Spillway after Revegetation of Chute and Stilling Basin

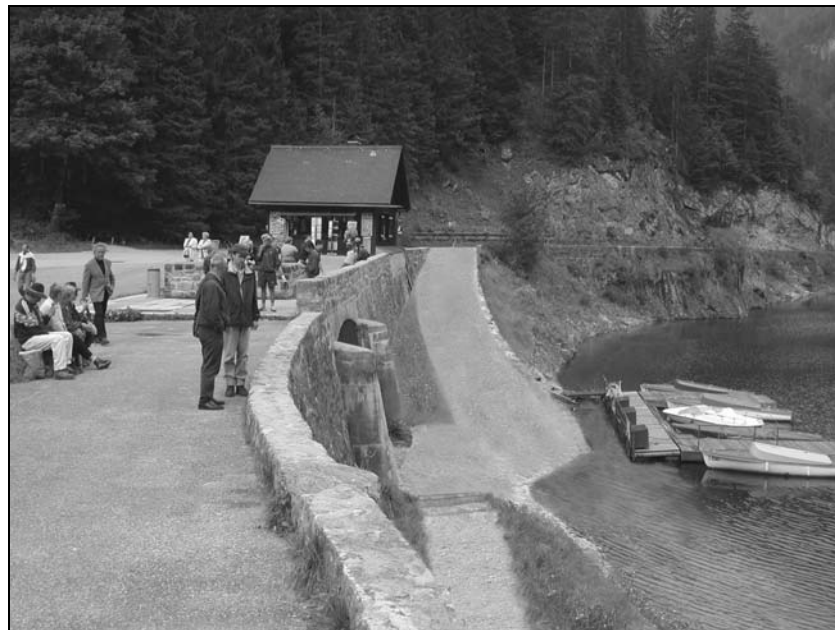
The ramp provided on the lake shore near the restaurant, which served as an access to the bottom-outlet site, can now be used as an improved approach to the boat mooring area (Fig. 12). New concrete walls were provided with limestone surfacing to match up better with the surrounding landscape. Certain sections of the lake shore were raised above the maximum operating level and planted with grass to allow access to the water. No artificial measures were taken in the remaining shore areas, allowing natural succession to proceed.

Figure 12. Boat Mooring Area in front of the old Spillway Tunnel
