SULPHIDE STRESS CORROSION CRACKING OF 1.4418 WELDED PLATES

Abstract

¹ ANDRITZ AG, Stattegger Strasse 10, 8045 Graz

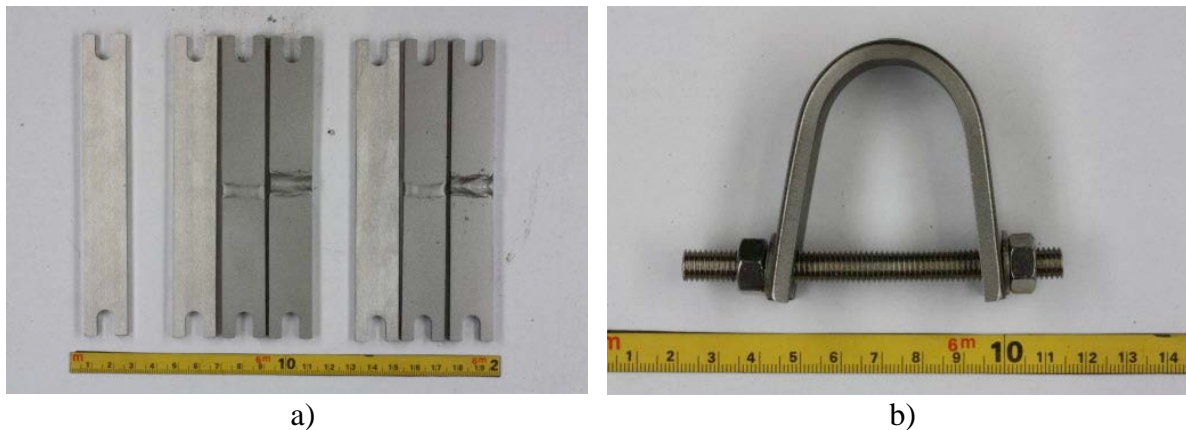
Fig.1: (a) 150x20x8mm samples of 1.4418 divided into three groups: from left to right the samples to be tested at room temperature, at 80°C and 100°C; (b) example of sample 2 with TIG weld after tensioning of the weld by bending

In Fig.1 a) the 3 groups of samples are shown. Only one sample without weld (RT) was tested at room temperature, whereas 3 samples were tested at 80°C and 3 samples at 100°C: each group was formed by a sample without weld, one sample with TIG welding seam and one sample with MAG welding seam. Fig. 1b) shows the side view of sample 2 after bending. The welding seam was placed in the most critical condition, i.e. the highest deformed area of the sample. Table 3 summarizes the different samples tested at room temperature, at 80°C and at 100°C.

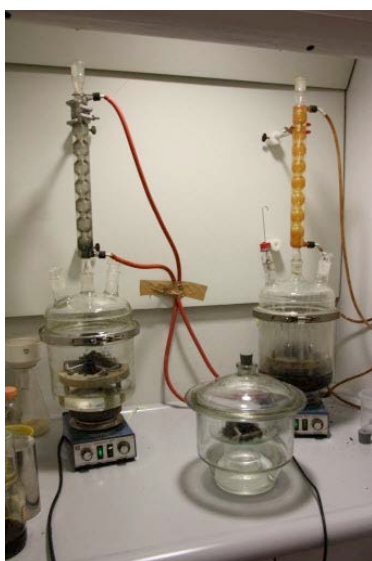
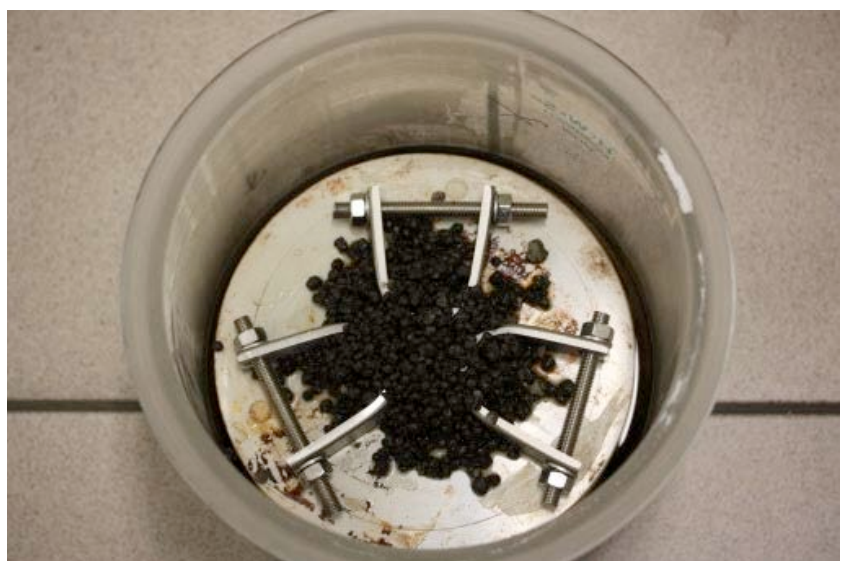
Fig.2: (a) setup of the experiment showing the equipment used for the test at room temperature, 80°C and 100°C; (b) disposition of the samples in the desiccator at 100°C

The sludge presents a considerable amount of chloride and sulphur. Fig.2 shows the three desiccators in the fume cupboard (a) and the samples lying on the plastic support and covered with sludge (b).

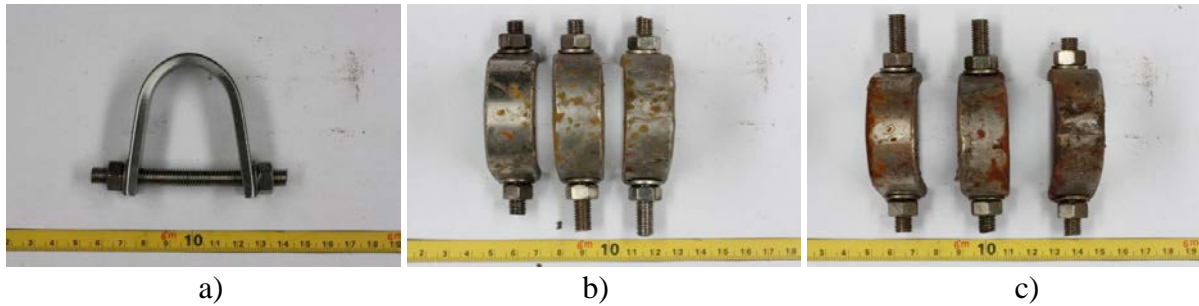
Fig.3: images of the samples at the end of the test before cleaning: (a) sample RT, (b) from left to right: samples 1, 2 and 3 tested at 80°C and (c) from left to right: samples 4, 5 and 6 tested at 100°C

Fig.3 shows the samples tested at room temperature (a) at 80°C (b) and at 100°C (c) at the end of the 6 months test before cleaning.

As can be seen in Fig. 3a almost no rests of sludge were visible on the sample tested at room temperature. The surface of the sample under tension was visually compared with images of the same sample before the test and no difference was noticed. Samples tested at 80°C (Fig. 3b) and at 100°C (Fig. 3c) showed sludge strongly attached to the surface. In order to proceed with the visual analysis cleaning by means of brush and sonic bath was necessary. Fig.4 shows the samples tested at 80°C (a) and at 100°C (b) after cleaning.

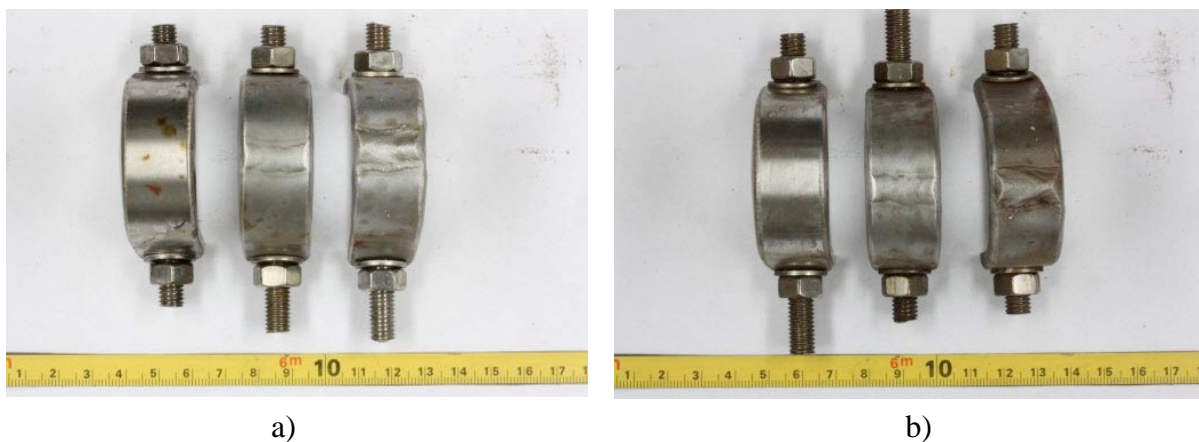
Fig.4: images after cleaning of (a) the samples tested at 80°C, from left to right samples 1, 2 and 3, and (b) the samples tested at 100°C, from left to right samples 4, 5 and 6.

After cleaning a first visual inspection was carried out on the samples side under tension. A naked eye analysis did not evidence any cracks or defects on the samples. A liquid penetrant test (PT) was performed on all samples with particular attention to the area with the higher deformation. Results confirmed the absence of surface cracks. All samples were further investigated by means of optical microscopy. Optical microscopy did not reveal any

defects on the surfaces of the samples with no welding seam (samples RT, 1 and 4) and the samples with a TIG welding seam (samples 2 and 5). During investigation of the samples with MAG welding seams (samples 3 and 6) small imperfections were noticed along the edge of the seam but were assessed as undercuts and not corrosion induced cracks.

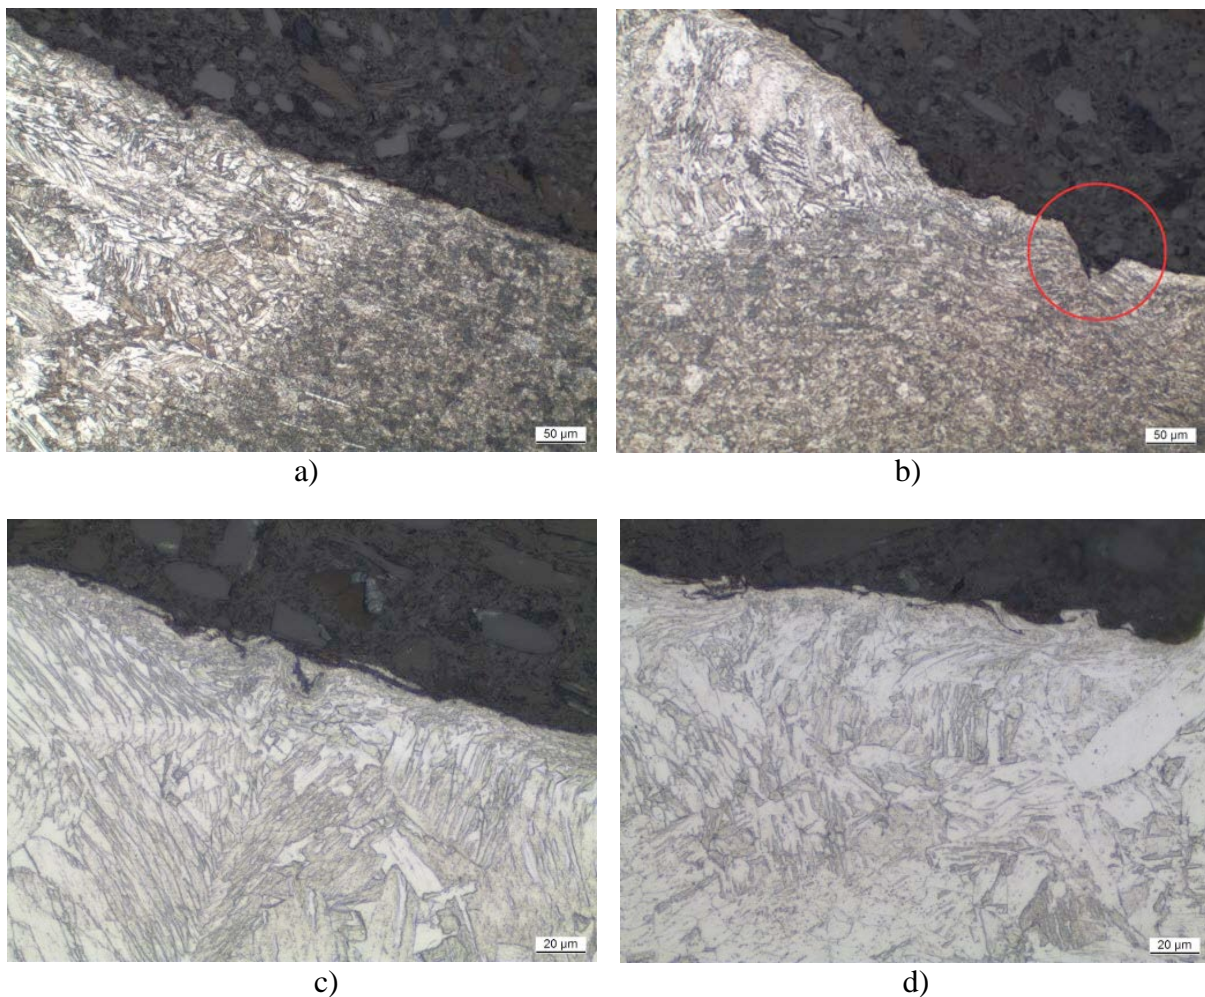
Fig.5: light optical microscopy images of the heat affected zone of (a) sample 5 and (b) sample 6, and of the welding seam surface on (c) sample 5 and (d) on sample 6.

Fig.5 shows light optical microscopy images of the heat affected zone in sample 5 (a) and sample 6 (b) and images of the welding seam surface taken from sample 5 (c) and sample 6 (d).

No corrosion cracks were found developing from the surface into the material across the grains or along the grain boundaries. As previously mentioned sample 6 shows an undercut in the transition area between the bulk material and the MAG welding seam (Fig. 5 b, indicated with a red circle). Although an undercut is generally considered having a negative influence

because it introduces notches in the samples, no corrosive attack could be detected in the notch.

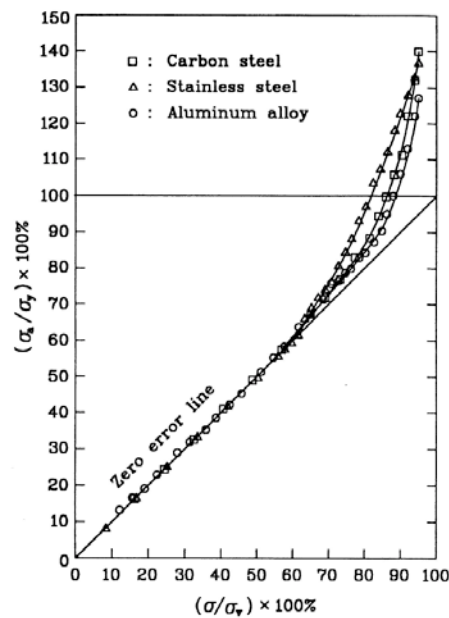
Fig.6: overestimation of the stresses measured on carbon steel, stainless steel and aluminium alloy when the stress exceeds approximately 70% of yield strength [4]

Residual stresses were measured using the hole drilling and X-ray technique. While the X-ray technique returns residual stresses only near the surface, the hole drilling method can be used to determine the residual stresses up to a depth in the range of 1 to 2mm assuming a planar stress field. However, due to the plastic bending of the samples bending stresses up to yield strength can be expected which makes an exact determination using hole drilling difficult. In first place bending always leads to a stress gradient in thickness direction and secondly very high stresses can be expected due to the loading conditions. When stresses exceed approximately 70% of yield strength, an overestimation due to notch stresses can be expected as shown in Fig.6. [4]

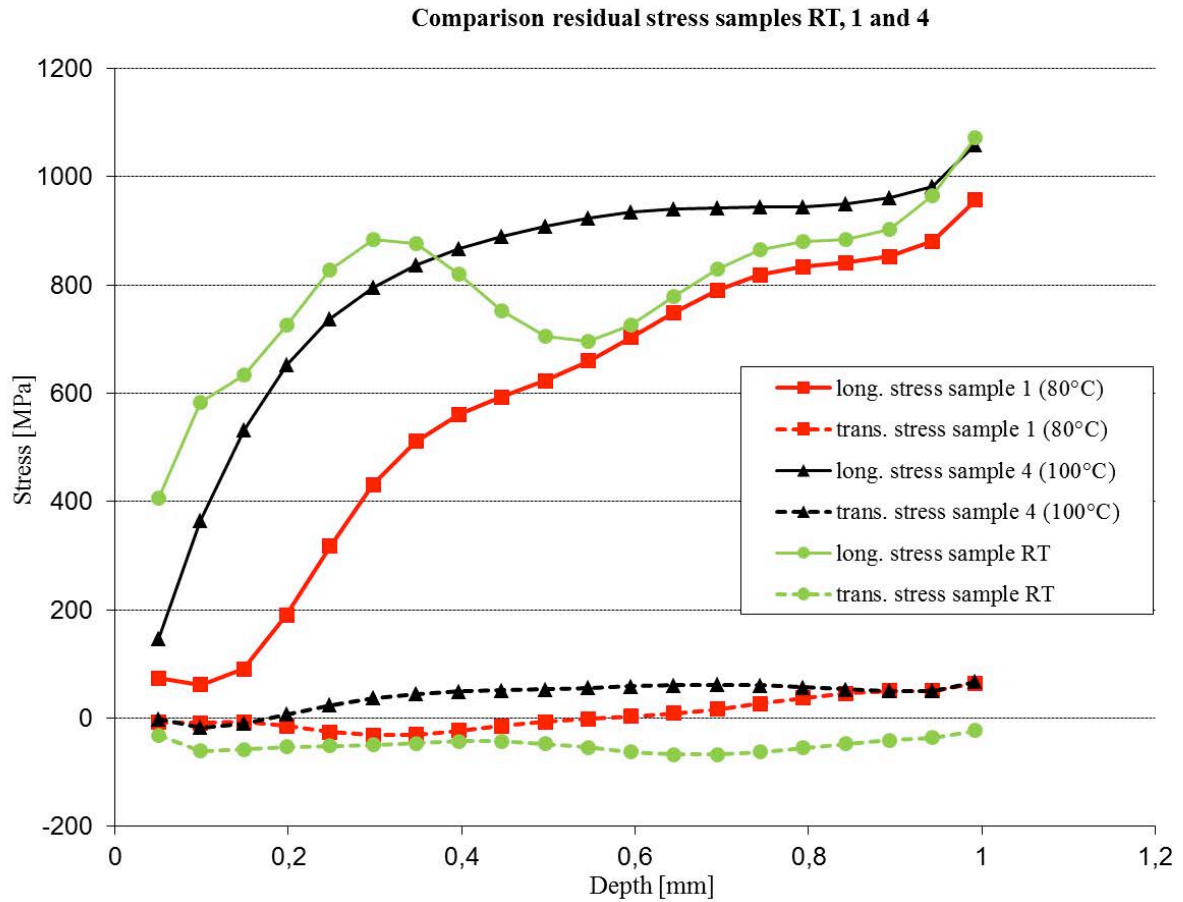
Fig.7: residual stresses measured on sample RT, sample 1 (tested at 80°C) and sample 4 (tested at 100°C)

Fig.7 shows the residual stresses measured on samples RT, sample 1 (tested at 80°C) and sample 4 (tested at 100°C) up to a depth of 1mm. Typically a depth up to 1mm can be analysed when a hole with a diameter of 1.6mm is drilled.

Since corrosion starts at the surface, the stresses close to the surface are significant. As shown in Fig 7 stresses transverse to the sample bending direction are approximately 0MPa. Bending stresses longitudinal to the bending direction show a significant increase from the top surface with increasing depth. Very low stresses near the surface could be explained by the stress redistribution due to plastic deformation after bending and too low load.
