# *Evaluation of State of the Art Methods for Surface Monitoring of Earth Filled Dams*

W. Lienhart, S. Lackner

Institute of Engineering Geodesy and Measurement Systems  
Graz University of Technology  
Graz, Austria  
werner.lienhart@tugraz.at

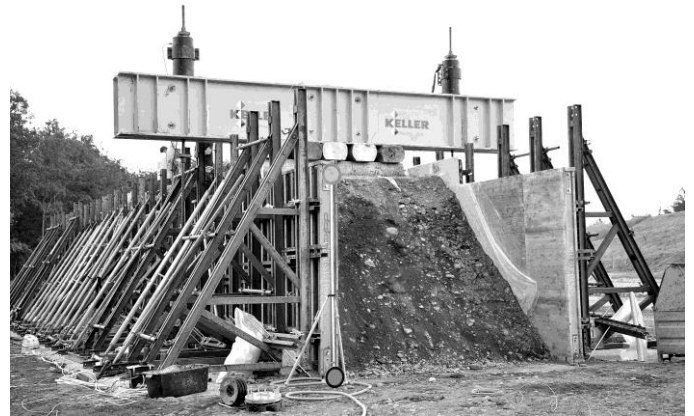
Figure 1. Experimental dam in the vicinity of the hydroelectric power plant

Several loading experiments have been carried out. In each experiment vertical load was applied onto the dam crest with a steel traverse and two hydraulic presses, see Fig. 1. Surface deformations of several centimeters were predicted from numerical simulations.

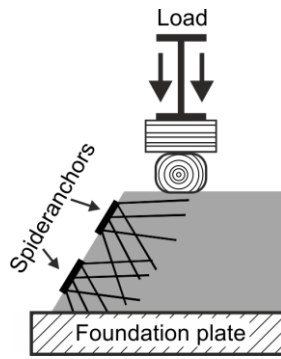
Figure 2. Experimental setup: stabilization with Spideranchors

The dam was either not stabilized, stabilized with two Spideranchors as indicated in Fig. 2, or stabilized with two Spideranchors and a geotextile. A Spideranchor consists of an iron anchor head and iron rods which are screwed through this anchor head in different angles into the ground [9]. The idea of the Spideranchor is to stabilize the dam like the roots of a tree.

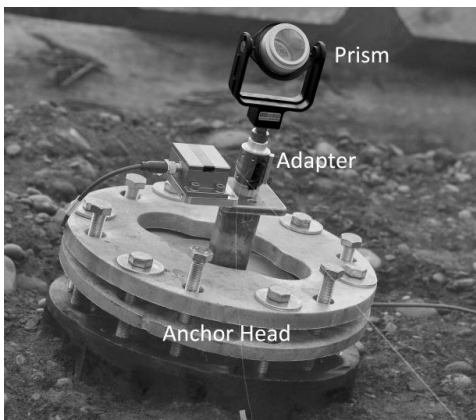
Figure 3. Detail view of monitoring point on Spideranchor head

The geodetic monitoring in this project is based on two robotic total stations and one scanning total station. Due to the expectation that the dam suddenly fails under load continuous 3D measurements with high precision and high sampling rate were necessary. The positions of the Spideranchor heads were continuously measured with two total stations in tracking mode. Therefore, special adapters for prism mounting and fiber pre-straining were developed, see Fig. 3.

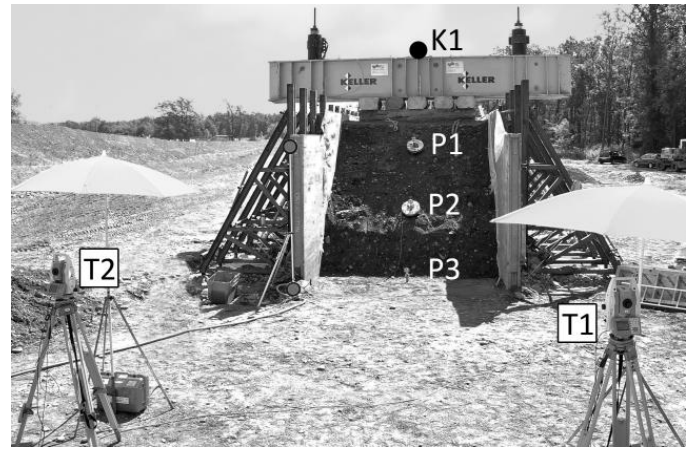
Figure 4. Measurement setup for the continuous monitoring of the anchor heads with two tracking total stations (T1, T2) and location of the inclination sensor (K1) on the steel traverse

The overall measurement setup is shown in Fig. 4. The prism P1 was tracked by total station T1 (Leica Geosystems TS15) and the prism P2 by total station T2 (Leica Geosystems TCRA1201). A third point P3 was installed as a reference point at the foundation plate of the dam and sporadically observed for stability. The total stations were remotely controlled with Matlab programs developed by EGMS. As a third total station the new scanning total station Leica Geosystems MultiStation MS50 was used for scanning the dam surface. This instrument has full total station functionality, fast direct drives and can measure up to 1000 points per second [4]. During all measurements meteorological data were collected for meteorological distance reductions. On top of the steel traverse a KELAG inclination sensor (K1) was installed to monitor inclination changes of the steel traverse during the load application.

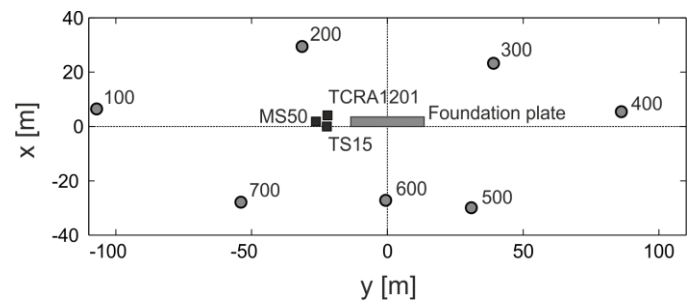
Figure 5. Local reference point network

A local reference network was established to analyze all total station data in a common coordinate system. Fig. 5 displays the position of the network points, the location of the foundation plate and the instrument positions for the experiment on August 30<sup>th</sup>, 2012. The center and orientation of the local coordinate system were aligned to the foundation plate of the dam. The positions of all total stations were determined by free stationing at the beginning of each experiment and verified again at the end of the experiments.

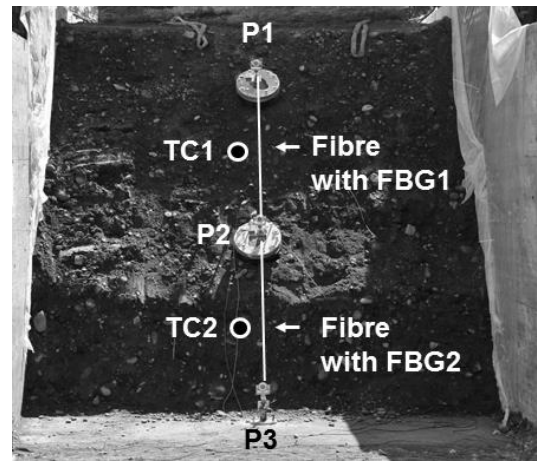
Figure 6. Position of two fiber bragg grating (FBG) sensors and thermocouples (TC)

FBG sensors are sensitive to strain and temperature changes, see e.g. [7]. Therefore, the local temperature was measured in the vicinity of the FBG sensors using electrical temperature sensors (thermocouples), see Fig. 6. Thus, strain and temperature could be separated using the calibration functions determined in the laboratory and the on-site temperature measurements.

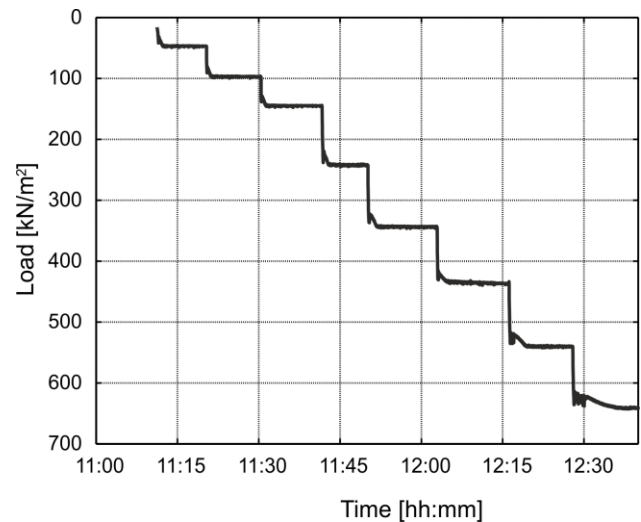
Figure 7. Stepwise increase of load on August 30<sup>th</sup>, 2012

In this article we focus on the results of the experiment on August 30<sup>th</sup>, 2012. In this experiment Spideranchors were used as stabilization method and the load was gradually increased up to 650kN/m<sup>2</sup> as shown in Fig. 7. The initial goal was to increase the load until the dam fails. However, as will be discussed later, the experiment was aborted due to deformations of the steel traverse caused by the high loads in combination with the high stability of the dam.

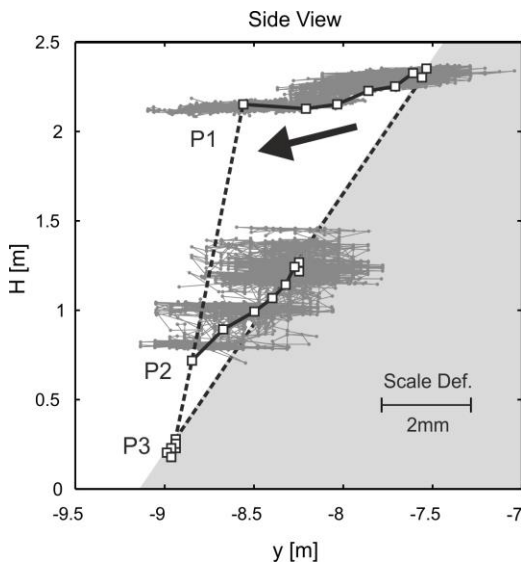
Figure 8. Static single point measurements (black squares) and continuous single point measurements (grey dots)

As explained before, static single point measurements were performed after each loading step. The derived movements of the anchor heads are displayed in Fig. 8. It is apparent that the anchor head movements are much smaller than expected. The movements of the anchor points do not exceed 5mm and prove a high stability of the Spideranchors. A detailed analysis reveals that P1 and P2 experience different deformation behavior. The movements of P1 are predominately horizontal whereas P2 moves almost the same amount horizontally and vertically. The total movements are about 4.8mm for P1 and 3.2mm for P2. Furthermore, the static single point measurements confirm the stability of the fixed reference point P3 at the toe of the dam. The measured coordinate variations of this point are within the measurement noise.

The results of the continuous single point measurements using the two robotic total stations are shown as grey dots in Fig. 8. The continuous measurements follow the trend of the static measurements but with high measurement noise. For P1, high measurement noise is only present for the y-coordinate, whereas all coordinate directions of P2 show high measurement noise.

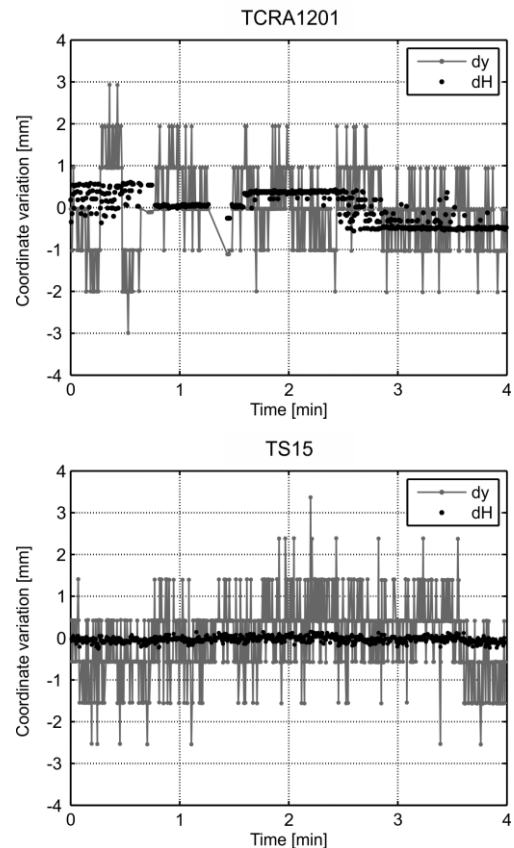
Figure 9. Coordinate variations during a stable 4 minute period of TCRA1201 (top) and TS15 measurements

This aspect can be investigated by analyzing the data of a stable period without any load applied. Fig. 9 displays the coordinate variations in y-direction and height for both total stations for a 4 minute time period. Thus, it appears that the y-coordinates have larger variations which result in a standard deviation of 1mm. These variations are caused by the noise of the distance measurements which correspond to the y-direction in our setup. Furthermore, it can be seen that the distance resolution in tracking mode is only 1mm for both instruments.

The performance in vertical direction differs between the instruments. The precision of height values is 0.4mm ( $1\sigma$ ) in case of TCRA1201 measurements and better than 0.1mm ( $1\sigma$ ) for TS15 measurements. The observed height variations are a result of the precision and resolution of the automated target recognition (ATR) sensors of the instruments. It has to be noted that the TCRA1201 and TS15 use different hardware and firmware for the ATR. The ATR sensor of the TCRA1201 is based on a CCD sensor whereas the TS15 uses a CMOS sensor which Leica Geosystems introduced first with their TPS1200+ series [2]. By analyzing the raw measurement data it was found that the ATR resolution of the TCRA1201 is only a full CCD pixel in the tracking mode. For the TCRA1201, this corresponds to about 40 $\mu$ m and results in jumps of the data. The resolution of the ATR of the TS15 is one tenth of a pixel and therefore a higher precision and smoother data is gained.

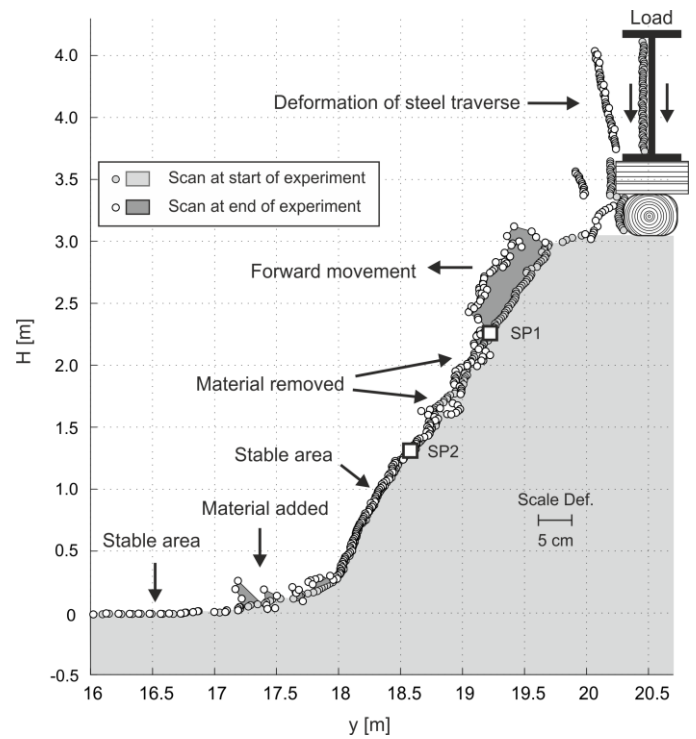
Figure 11. Deformations along the vertical single scan line between the start and the end of the experiment

First we concentrate on the deformation analysis of one single vertical scan line. The selected scan line is indicated in black in Fig. 10. Deformations of points along this scan line were calculated with Matlab using scan data from different loading steps. The deformations between the last loading step (650kN/m<sup>2</sup>) and the initial unloaded state are shown in Fig. 11. For better visibility the deformations are exaggerated by a factor 5. It is apparent that the area above the Spideranchor SP1 bulges out several centimeters. The area below the Spideranchor SP1 is almost stable, thus confirming again the high stabilization capabilities of the Spideranchors. It can also be seen that in some areas material slides down and accumulates at the toe of the dam.

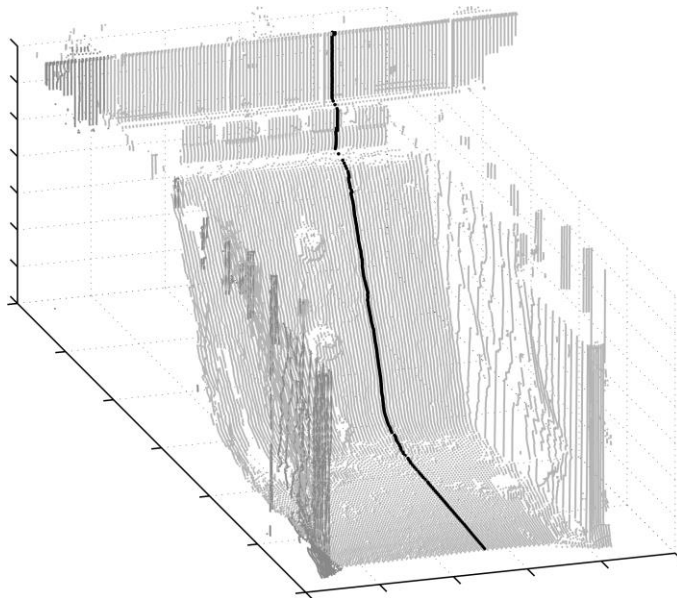
Figure 10. Point cloud of dam surface and single scan line for detailed analysis

The whole dam surface was scanned after each loading step with a distance measurement rate of 1000Hz. Fig. 10 displays the measured point cloud of one scan with 50 000 points.

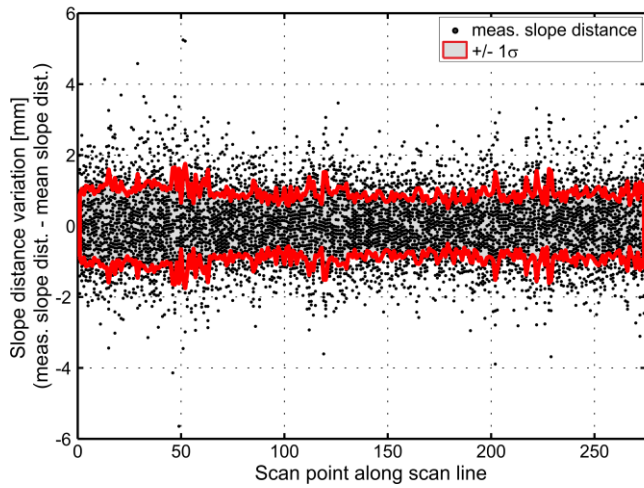
Figure 12. Precision of the observed slope distances

Fig. 12 displays the distance variations for all 270 points of the line. It can be seen that the mean standard deviation of the distance measurements is 1mm which corresponds well to the specifications of the instrument.

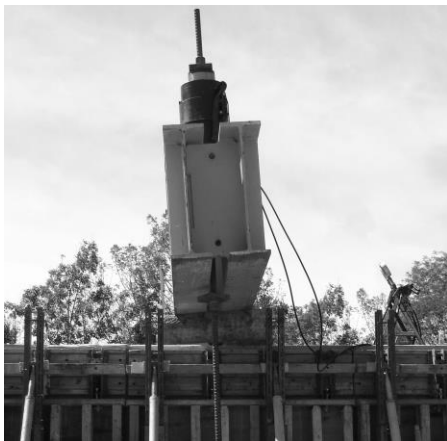
Figure 13. Deformations of steel traverse at 650kN/m<sup>2</sup>

The loading experiment on August 30<sup>th</sup>, 2012 had to be aborted due to large deformations of the steel traverse. Fig. 13 shows the tilt of the steel traverse at a load of 650kN/m<sup>2</sup>. Since deformations of the steel traverse have already been expected prior to the experiments a KELAG dual axis inclinometer SCA124T-D04FA was mounted on top of the steel traverse to observe inclination changes.

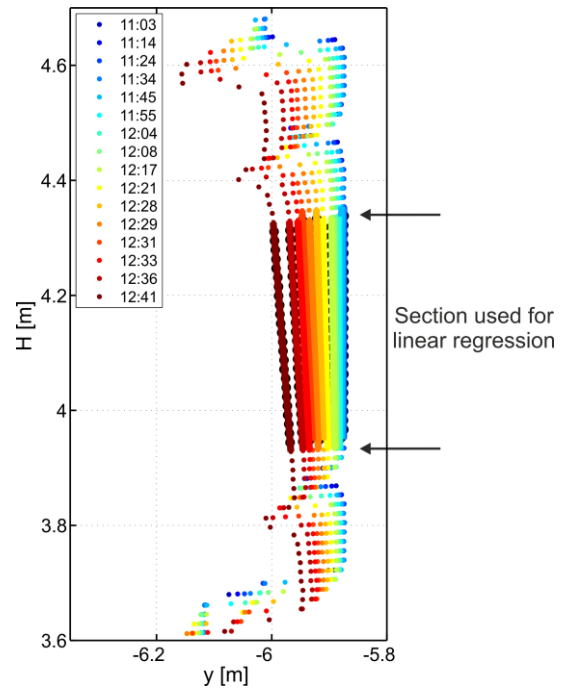
Figure 14. Scanning points on steel traverse from 11:03 to 12:41

Additionally, the deformation of the steel traverse could also be derived from the scanning data. Therefore, regression lines were estimated from the scan data of different loading steps using measurement points of the straight section of the steel traverse, see Fig. 14. The maximum deviation of the scanning points to the regression lines is about 1.9mm and the standard deviation of the estimated inclination is better than 0.1°.

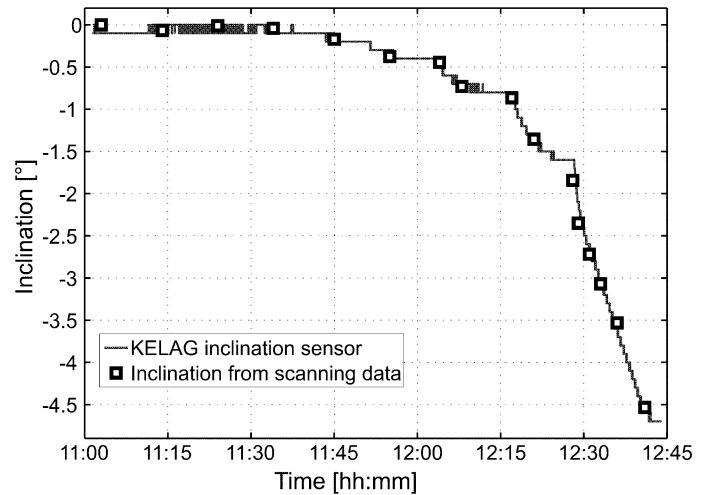
Figure 15. Inclinations measured with inclination sensor and inclinations derived from scanning data

Finally, these estimated inclinations were compared to inclinations measured with the KELAG inclination sensor. The derived inclinations are in good agreement to the measured inclinations as can, see Fig. 15. Maximum deviations between measured and calculated inclinations are less than 0.3°.

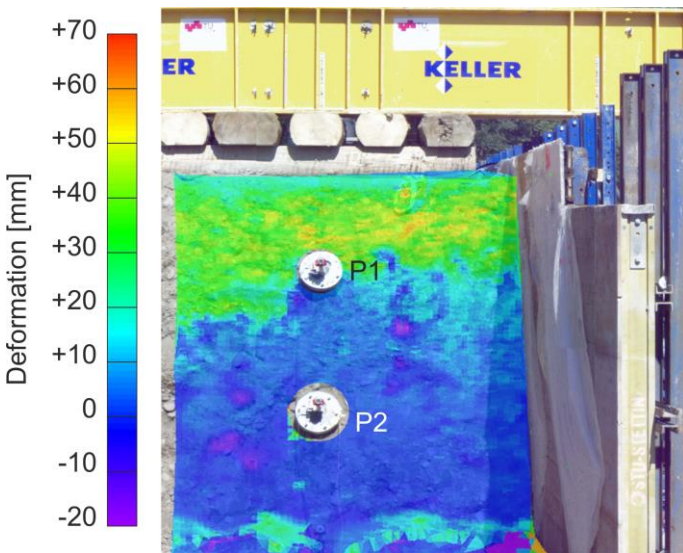
Figure 16. Deformations calculated from point cloud data

Deformations of the whole dam surface using the point cloud data were calculated using Leica Geosystems GeoMoS v6.0. Fig. 16 displays the result of the deformation analysis using point cloud data from the unloaded state of the experiment and from the last loading step ( $650\text{kN/m}^2$ ). It is apparent that the upper part of the dam slope experiences a forward movement of several centimeters. Compared to the movements of the prisms on the anchor heads, these movements are more than ten times higher. In some areas material, mostly stones, was sliding down and causing negative deformations. This material was accumulating at the toe of the dam.

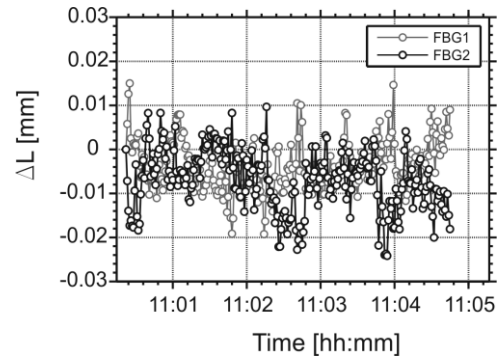
Figure 17. FBG measurements during the initial stable phase showing the measurement noise

Relative anchor head movements can be calculated from the geodetic 3D positions or directly be measured with the fiber optic sensors. The measurement noise of the FBG measurements can be determined by analyzing the data of a stable period. Fig. 17 shows the measurement variations within 5 minutes in the unloaded state of the experiment. A standard deviation of better than  $7\mu\text{m}$  can be derived from these data for both sensors which is remarkable keeping in mind the difficult measurement conditions in the field.

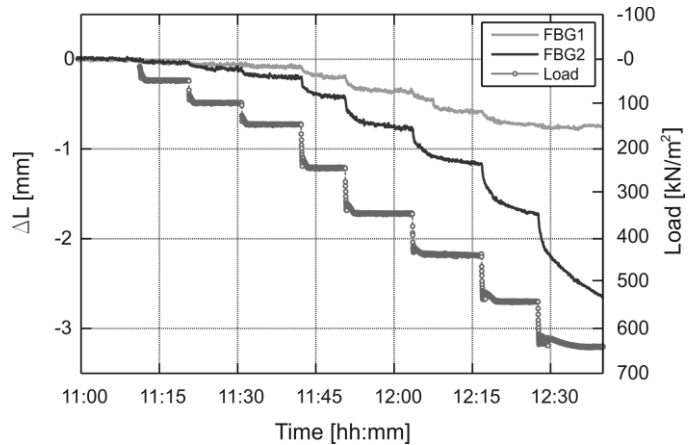
Figure 18. Load steps and results of dynamic fiber optic measurements

The results of the dynamic fiber optic measurements are displayed in Fig. 18. It can be seen that the FBG sensors depict relative movements between the anchor points immediately after the load is increased. Furthermore, the creeping behavior of the movements, e.g. between 12:18 and 12:25, is visible by these measurements.

The distance between the anchor heads P1 and P2 (FBG1) and the distance between P2 and the fixed reference point P3 (FBG2) was decreasing as expected. The length change at the end of the experiment is about  $0.8\text{mm}$  (approx.  $600\mu\epsilon$ ) for the distance P1-P2 and about  $2.7\text{mm}$  for the distance P2-P3 (approx.  $2200\mu\epsilon$ ).

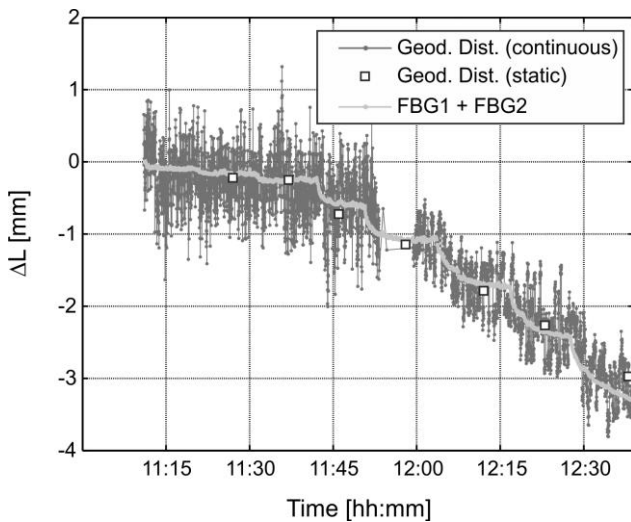
Figure 19. Length changes between P1 and P3 derived from geodetic and fiber optic measurements

To verify the results, we compared the FBG measurements with the TS15 total station measurements. Fig. 19 shows the results of the two different measurement techniques. Displayed are the length changes between the anchor point P1 and the fixed reference point P3. This corresponds to the sum of the two FBG readings. For the geodetic data distances were calculated from the continuously tracked 3D coordinates of P1 and the known coordinates of the fixed reference point P3. Although the precision of the geodetic and fiber optic measurement techniques is completely different, it can be seen that the overall deformation can also be detected with the continuous and static geodetic measurements. However, the deformations caused by the individual loading steps and the creeping behavior are only measurable with the fiber optic sensors.
