T. Planko¹, H. Fitzek¹, S. Eichinger³, J. Rattenberger¹, G. Koraimann⁴, H. Zeithofer⁵, M. Peyerl⁵ and H. Schroettner^{1,2}

Results MIC – Investigations

Chlorid corrosion – Investigations

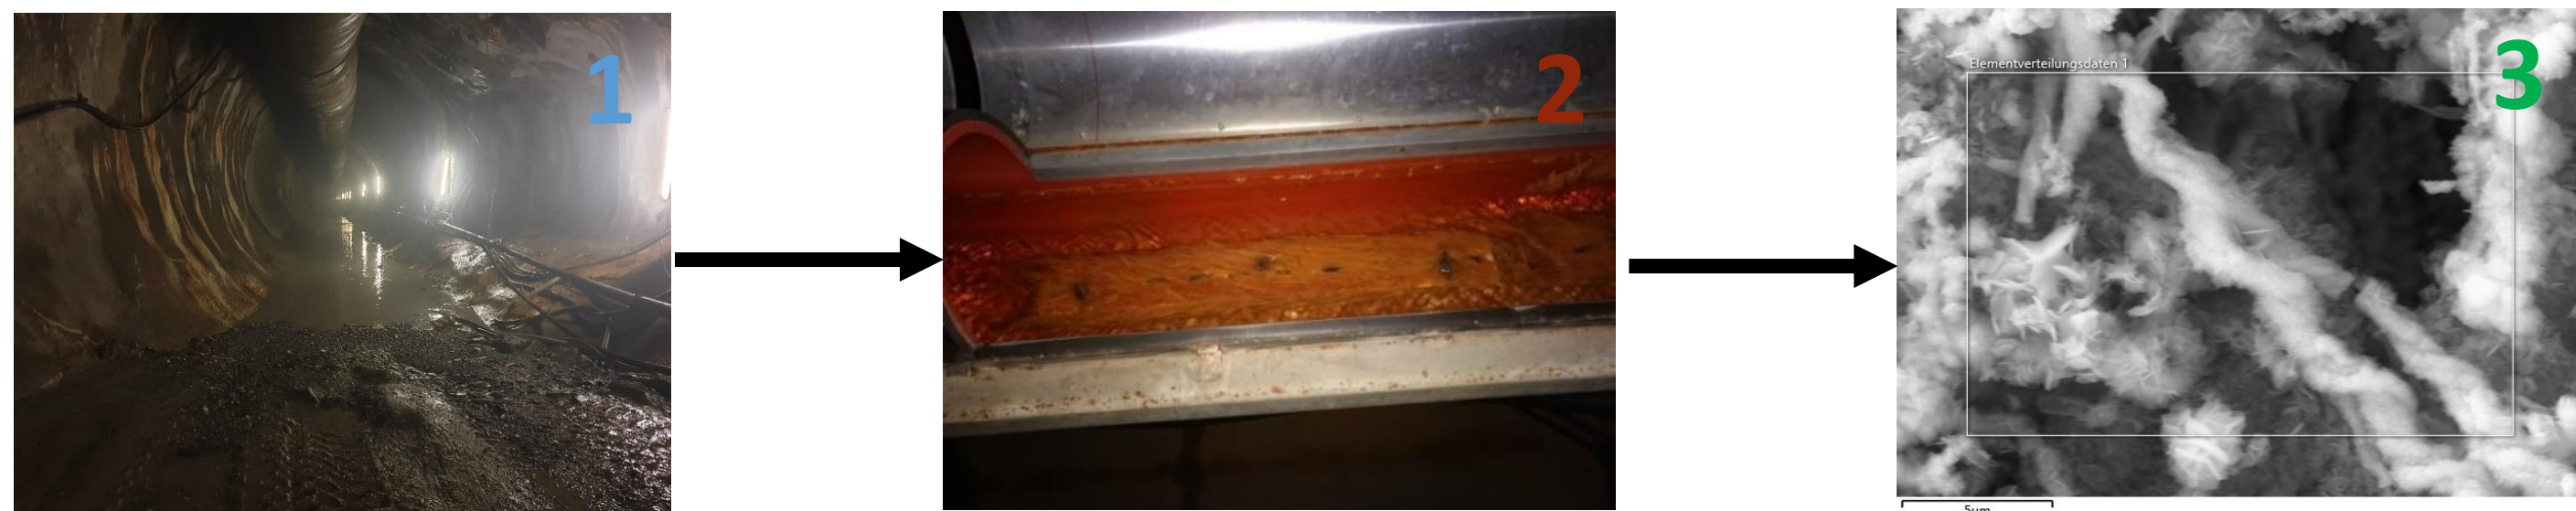
During experiments in the Koralmtunnel (1) iron oxidizing bacteria were found to be part of a biofilm (2) producing microbial community dominated by a variety of eubacterial methanotrophs. Microbial community analysis (16S profiling and metagenomic studies) from biofilm samples revealed the presence of different species from the family of Gallionellaceae (3). The flow of electrons from Fe^{++} is used by autotrophic bacteria such as *Ferriphaselus* sp. to generate energy e.g. for CO_2 fixation processes and concomitant production of biomass.

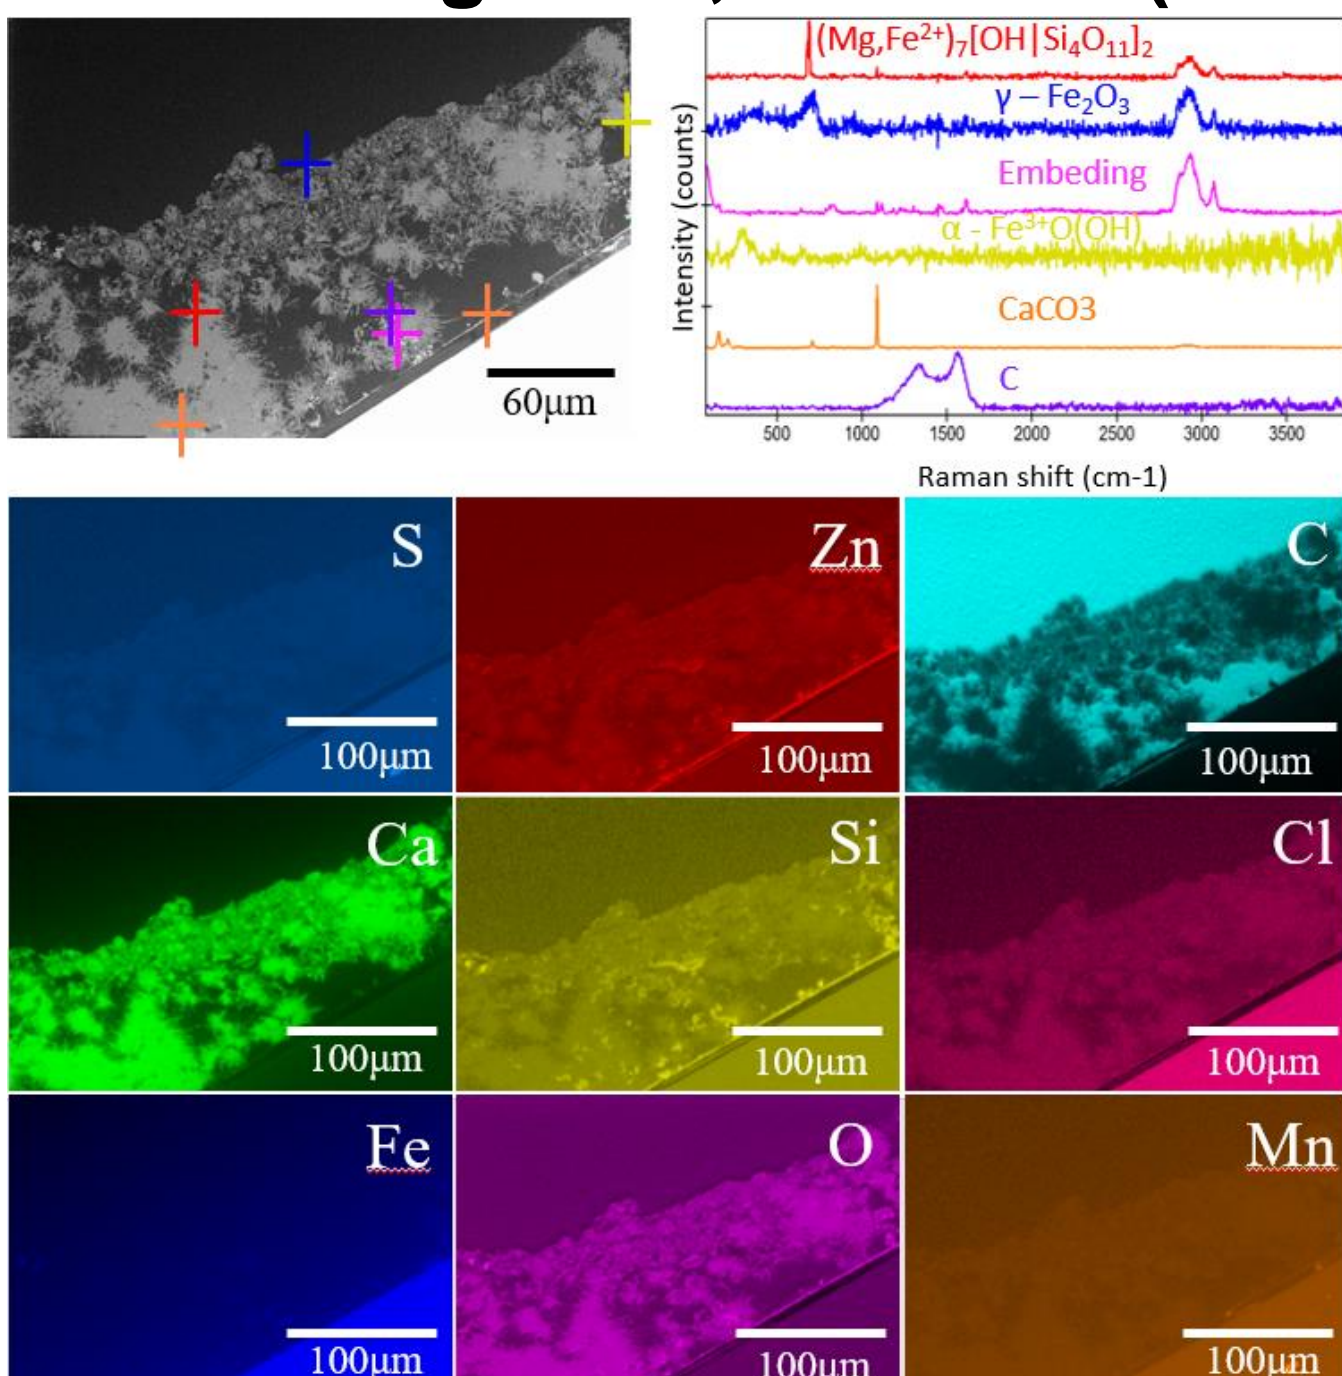
Free cutting steel, untreated (reference)

Fig.1: Left: Cross section of free cutting steel, untreated Reference Sample (1.0711) (SEM). The crosses marks are the Raman measuring points.

Right: Fe-oxides were identified with raman spectroscopy as Magnetite (blue) and Goethite (blue). In addition, cumingtonite could be detected, a rare mineral that, according to literature, occurs in the Lavantal Alps in Carinthia, among other places.

Bottom: Edx measurements with most important elements: Sulfur, zinc, carbon, calcium, silicon, Chlorine, iron, oxygen and manganese.

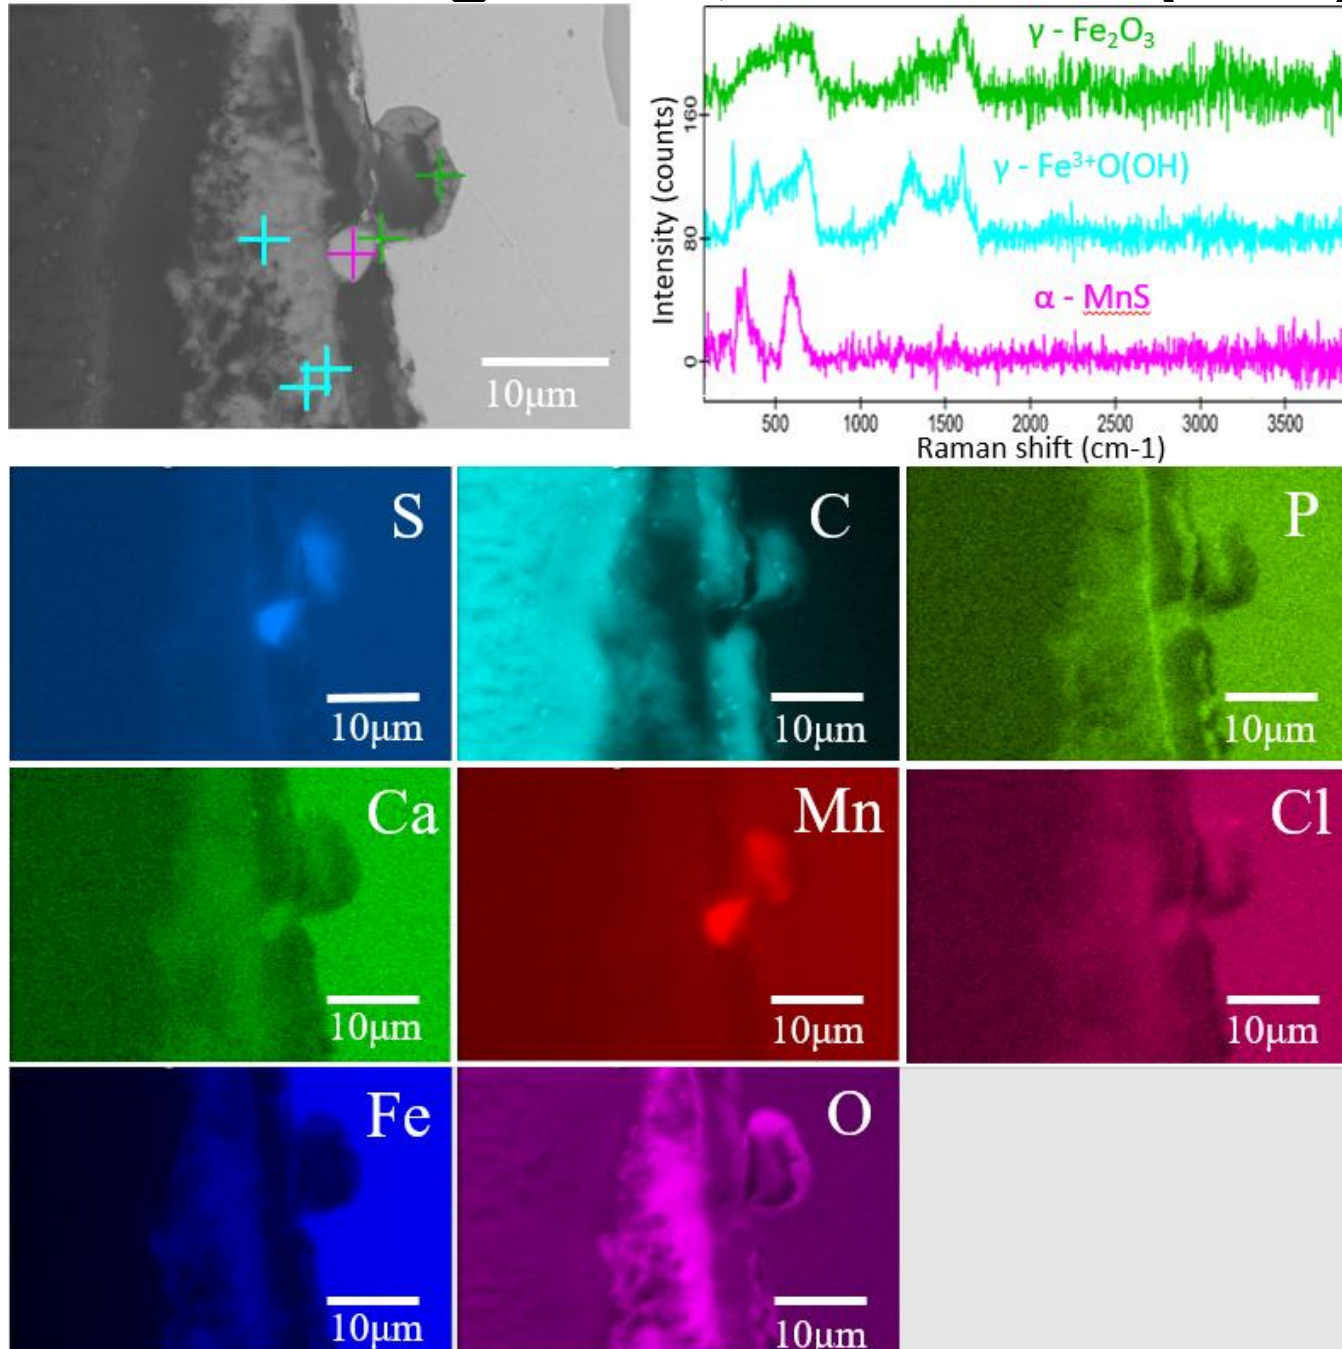
Free cutting steel, untreated (MIC)

Fig.2: Left: In the SEM-picture you can clearly see a pit caused by pitting corrosion.

Right: In addition to the iron-oxides found on the reference, Lepidocrocite and the Metal-sulfide Mangan(II)-sulfid could be detected on the MIC sample.

Bottom: In the EDX-mapping a sulfur layer is visible like in all MIC Samples that presumably formed due to MIC. In other measurements the sulfur layer was identified as Sulfur oxide by Raman.

The corrosion rate and pitting corrosion determined by ASTM standard [6] showed that the MIC samples had 2-6 times lower corrosion rate but stronger pitting corrosion. This could be due to the fact that discontinuous sulfur layers formed on all MIC samples, which may have slowed the corrosion rate, but created vulnerabilities for pitting corrosion due to the discontinuities.
